**A SURVEY OF SOME ARCTIC BEACH ZONES
IN SOUTHWEST CORNWALLIS ISLAND, N.W.T.**

H.E. Sadler and H.V. Serson

January 1981

DREP Report 81-1

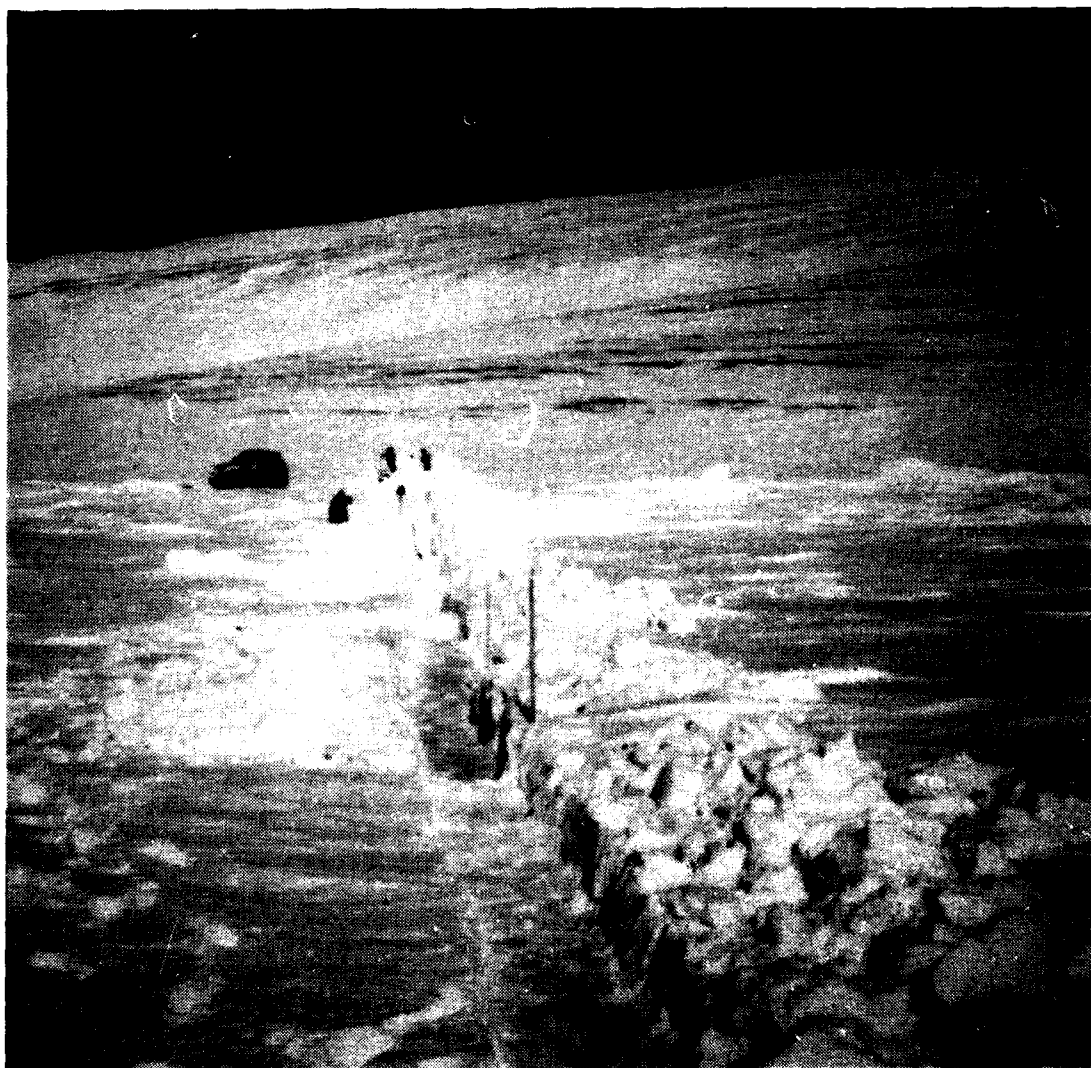
Frontispiece The snow trench at Cape Martyr Station A. The depth of the snow varies from about 30 cm to more than 2 m. The marker poles indicate survey points along the trench.

We surveyed six stations in May 1978, and repeated two of the surveys in May 1979 together with one at an additional station. At each place we established a survey marker on the beach berm or behind it and then cut a trench about one metre wide at right angles to the beach. We removed the snow down to the beach gravel or the ice and recorded the level of the ice surface at about 20 points along the trench, out to a point well beyond the last working tide crack. At each survey point we recorded the ice thickness, the water depth, the freeboard of the ice and the depth of the snow cover. We sketched the ice surface between survey points using tape measure distances and heights, and we noted the positions of all cracks. At the end of each line we carried out current measurements, obtaining current profiles every metre down to 10 m. We measured the temperature and salinity profiles of the ice and carried out compressive strength measurements, snow density measurements and current readings.

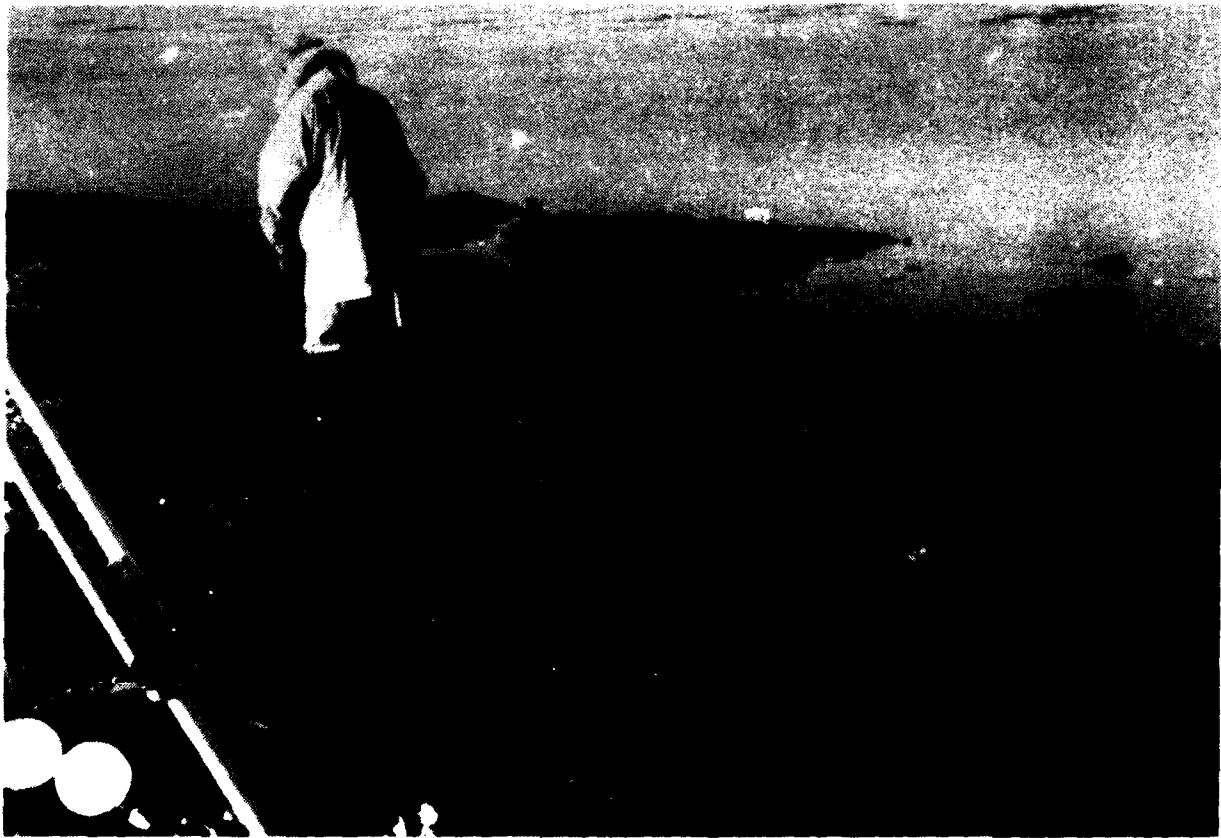
Figure 29. The timer pit and trenches cut into the gravel at Sight Point Station.

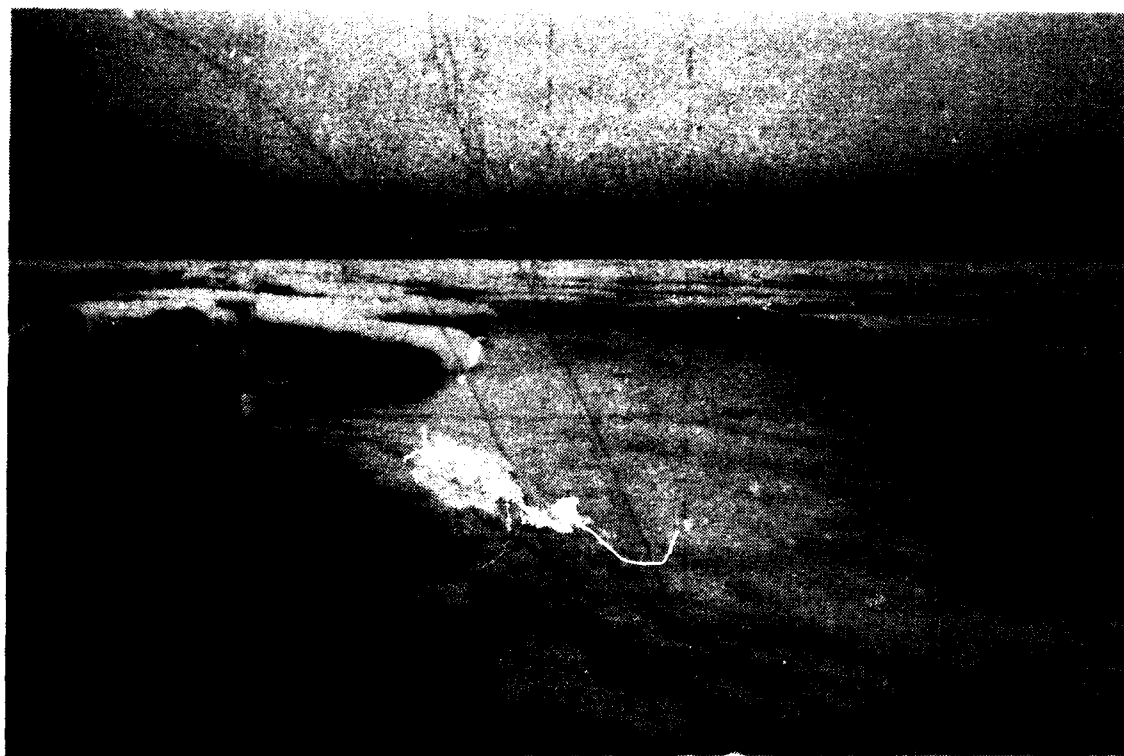
Figure 33. Belt of fresh-water anchor ice at Sight Point Station. The upper surface is clear of gravel but is scored by the movement of floes above it. The floes in the middle distance are about 1.5 m thick and have gravel frozen into their lower surfaces. The photograph was taken at the time of LLWS.

A further factor which must be considered in the survival of cables is the existence of a belt of anchor ice along the shore just off the beach (Figure 33). Sadler and Serson (1981) examined this belt and discovered that it was made up of fresh water ice. It extends two or three metres out from the low water line and is found along much of the beach. In August 1978, for example, about 70% of the beach over a distance of 30 km had this strip along it. It was 30 to 50 cm thick and was bonded to the

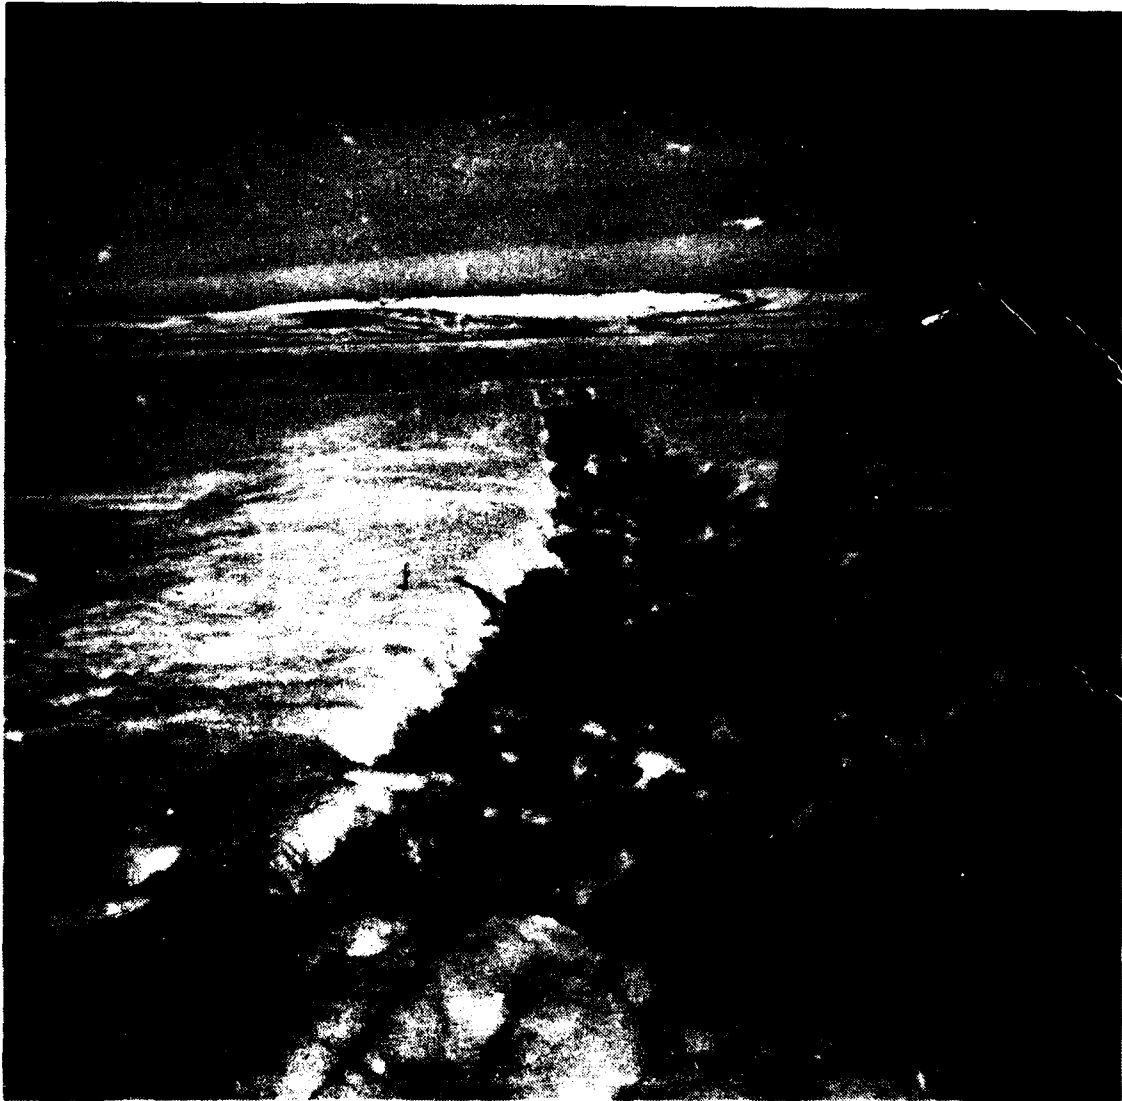
Figure C3. View of the gravelled strip from the beach end on 4 July 1978. Ablation stakes were set both in the treated and untreated areas.
